CASE STUDY – UTILIZING THE BIOCIDES ACTIVITY KIT IN AN INDUSTRIAL ENVIRONMENT

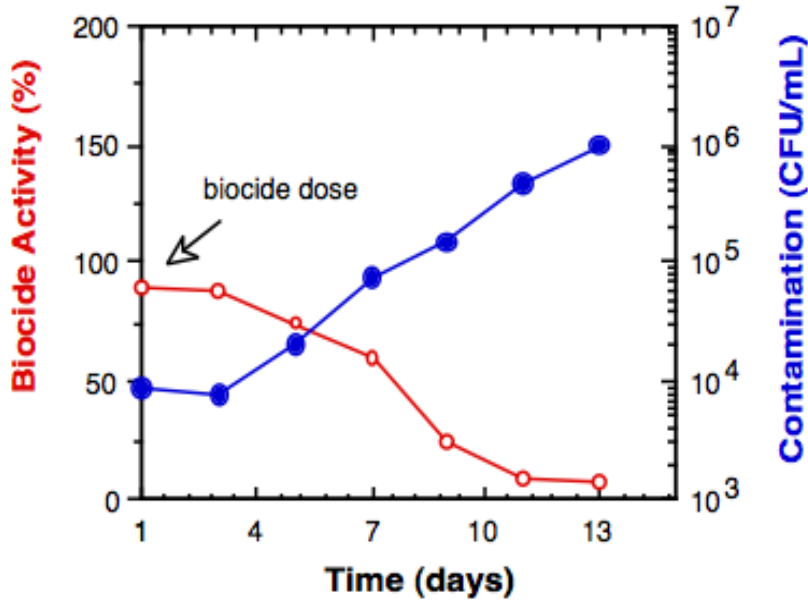
Figure 1 shows too long a delay before dosing the water and as a result the level of microbiological contamination rises well above the acceptable level of 10^5 CFU/ml.

CheckLight was able to demonstrate that its **Biocides Activity Test Kit** could give vital real-time information of biocide activity. Not only that, but the real-time measurements now enabled the service provider to identify the most suitable dosing points and optimal dosing regime for each client's system. Typical measurements taken from two of the systems before any rectifying action was taken are shown in Figures 1 & 2.

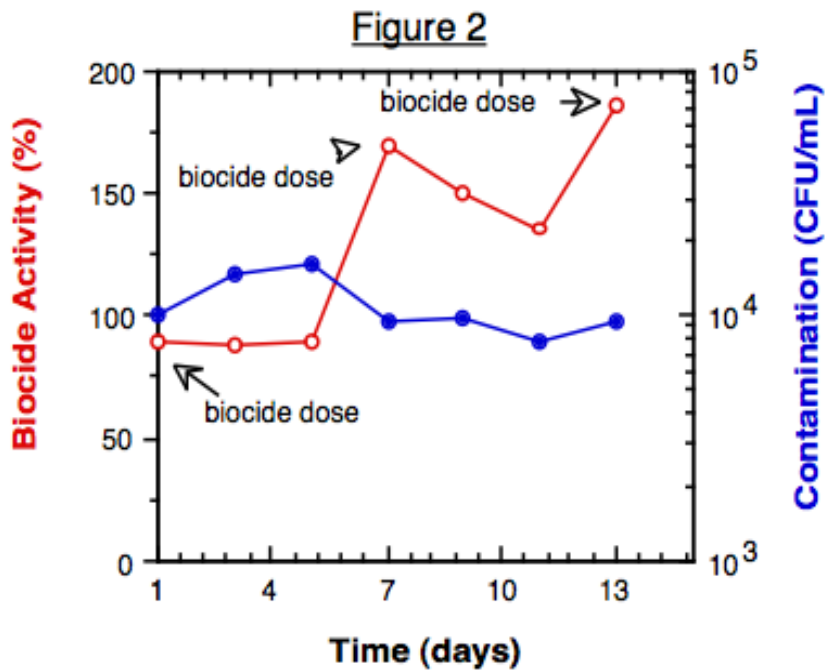
Figure 2 shows that the level of contamination is well below the permitted level but only because of wasteful overdosing of chemical reagents to the water.

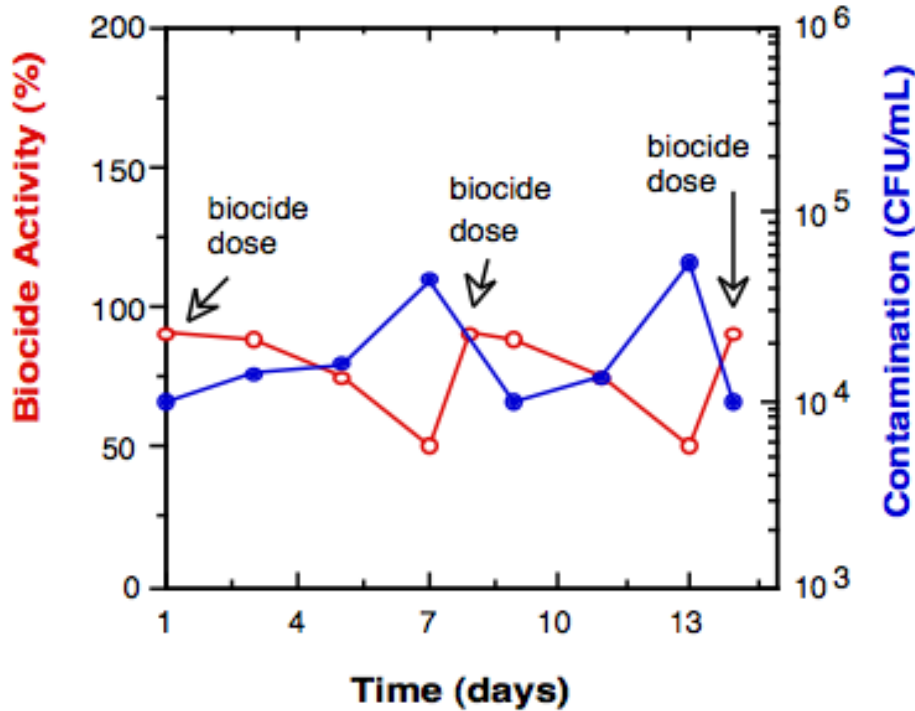
Figure 3

After initiating a program of measurements the service provider was able to optimize the sequence and quantity of chemical dosing needed to maintain the water below the accepted level, as shown in Figure 3.
